RESEARCH MEMORANDUM

PERFORMANCE OF AS-FORGED, HEAT-TREATED, AND OVERAGED

S-816 BLADES IN A TURBOJET ENGINE

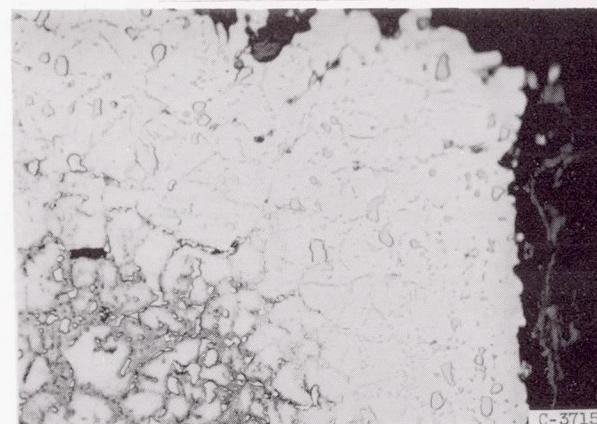
Same area as above. Very thick carbides and very little matrix precipitation.

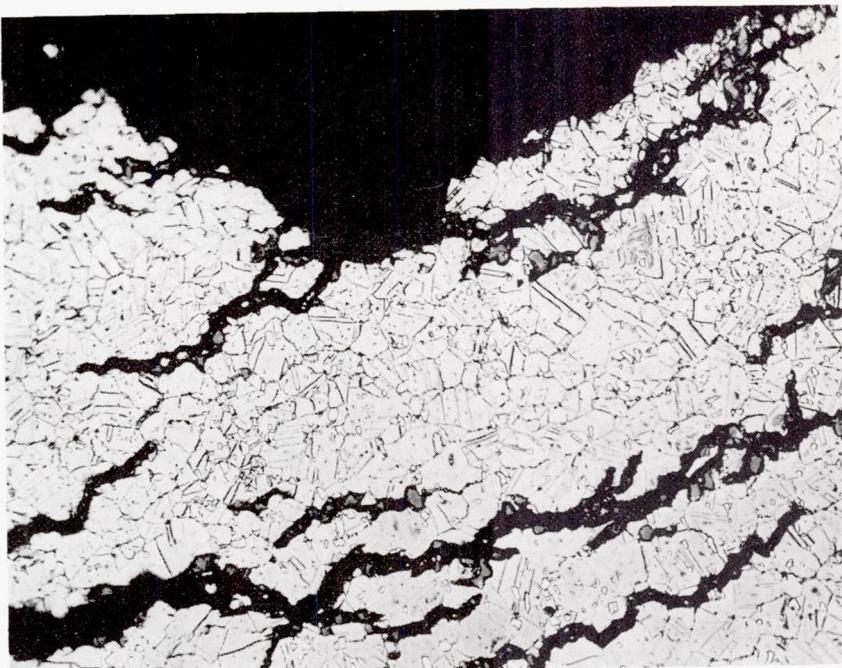
Stress-rupture portion of fracture edge and typical stress-rupture cracks. Etched in 5 percent aqua regia in water electrolytic followed by 10 percent HCl in alcohol electrolytic.

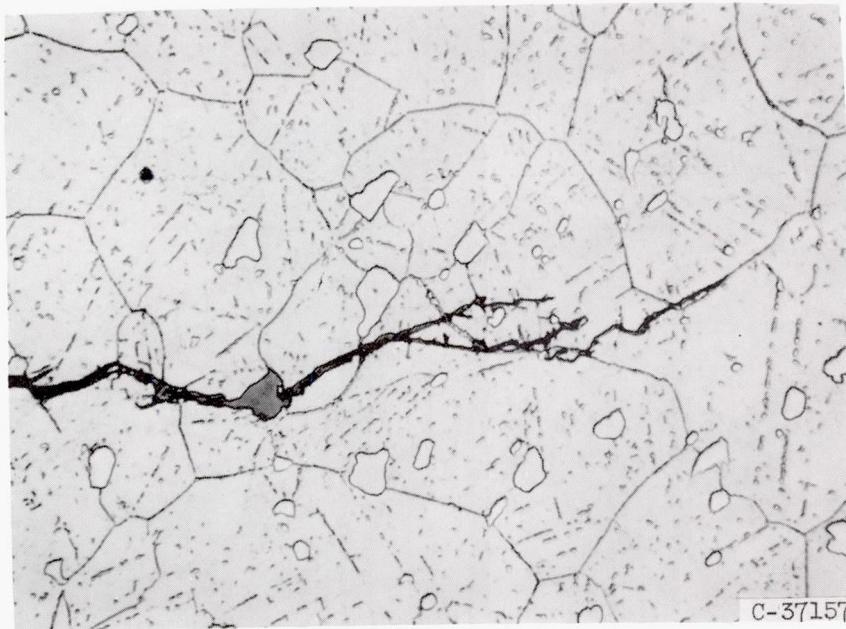
Fatigue cracks which radiated from main fracture edge which failed by stress-rupture followed by fatigue. Etched in 5 percent aqua regia in water electrolytic followed by 10 percent HCl in alcohol electrolytic.

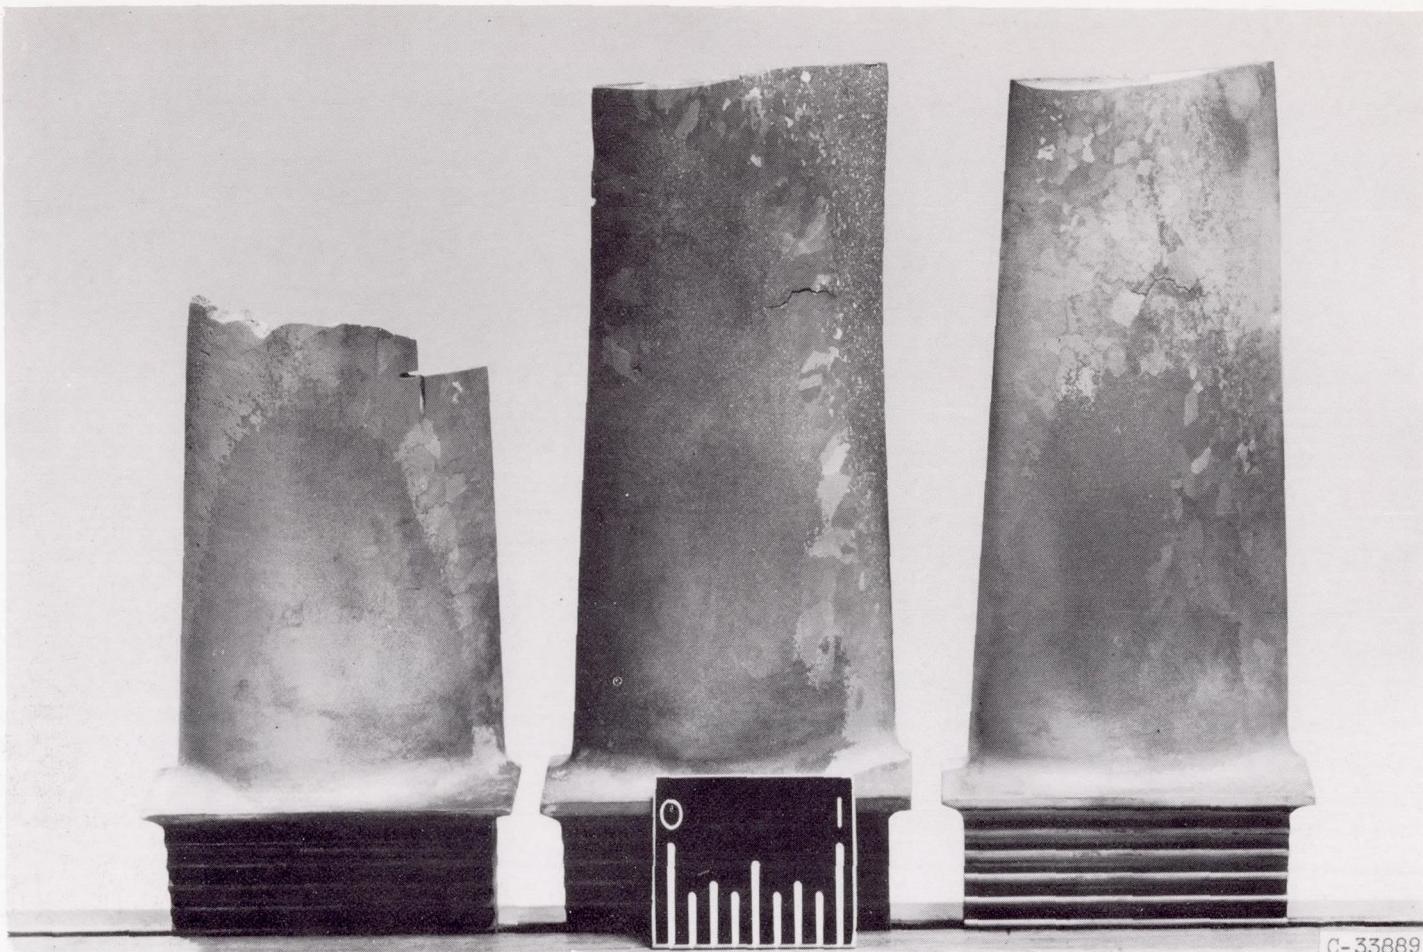
Figure 10. - Blades of group 5 with germinated grains revealed by macroetching.

Grain size. - Macroetching of specimens from different groups revealed no grain germination in any blades except those of groups 5 and 6. Photographs of macroetched specimens from these groups are shown in figures 10 and 11. According to the usual concept of grain growth, the areas in which germinated growth has occurred are areas in which critical stresses were produced by forging. The photographs show that most of the blades had received critical amounts of deformation in the leading and trailing edges and in the upper-third portion of the blade airfoils. Stress-rupture cracks are shown in figure 10. Blade 3 of figure 11 has uniform grains throughout except at the extreme leading and trailing edges at the tip. This blade, which was a first failure, failed by fatigue in an area where germinated grains were adjacent to microscopic grains.

(a) Blade 1. Failed by
stress-rupture in
285.17 hours.

(b) Blade 3. Failed by
stress-rupture cracking
in 142.50 hours.

(c) Blade 6. Failed by
stress-rupture cracking
in 49.25 hours.

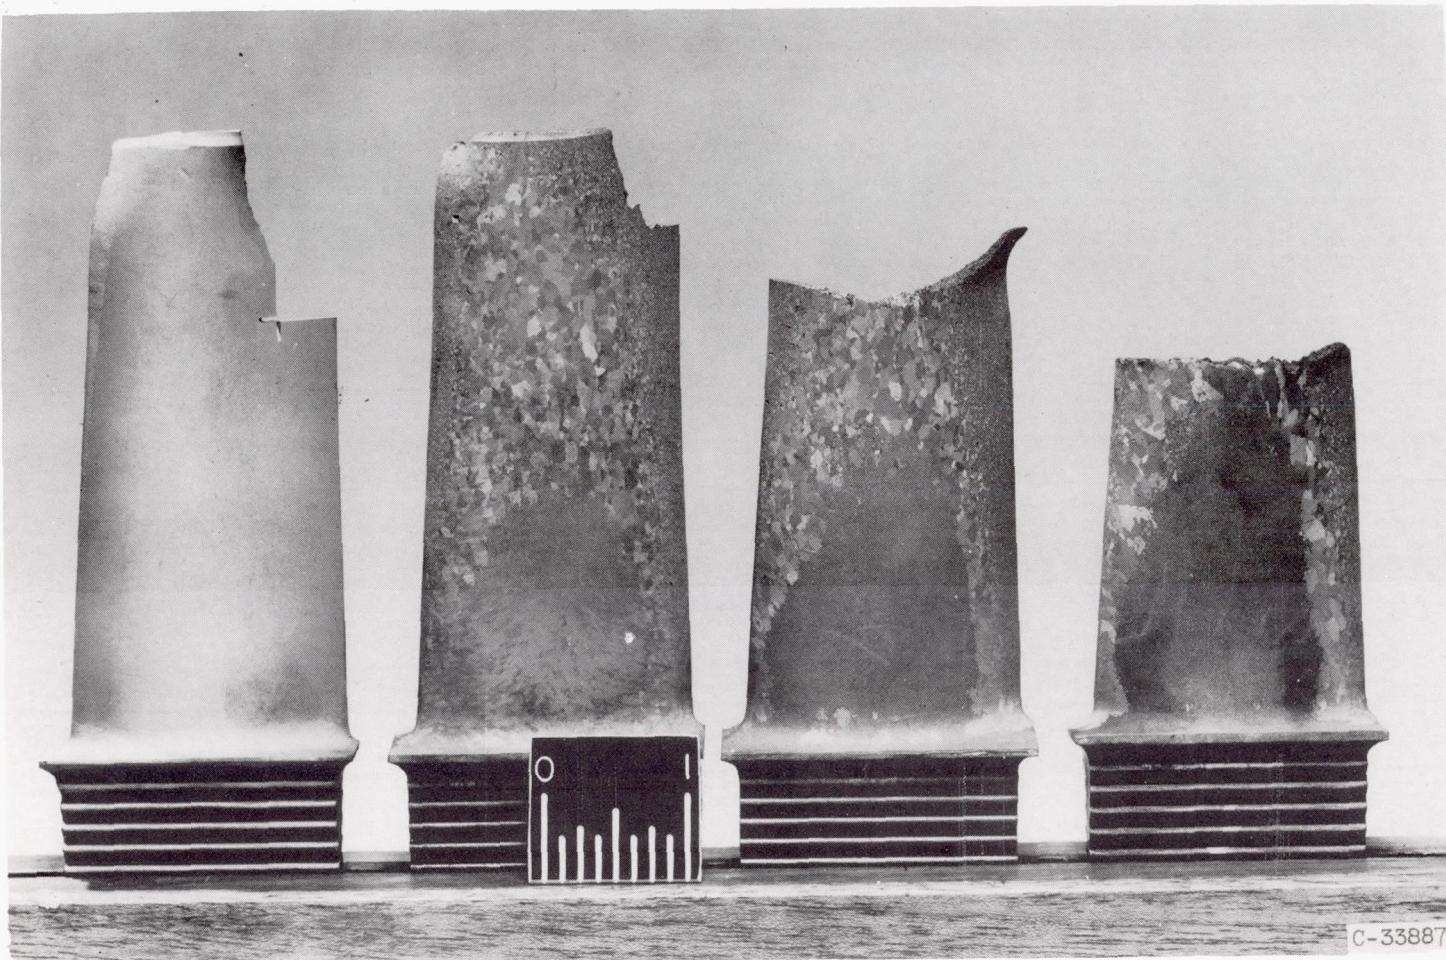
Figure 11. - Blades of group 6 with germinated grains revealed by macroetching.

(a) Blade 3. Failed by (b) Blade 2. Failed by (c) Blade 1. Failed by (d) Blade 5. Failed by
fatigue in 59.17 hours. damage in 93.43 hours. fatigue in 99.28 hours. damage in 209.25 hours.
